# University of Pittsburgh

Cathedral of Learning Exterior Preservation 2007

AUA Case Study 2008

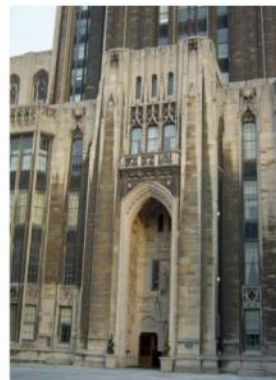
A photo of the south elevation shows the evidence of atmospheric pollution (May 2005).
