# University of Georgia

## Creating a Useful Historic Plan

## *What is the appropriate Historic Preservation Master Plan for the University of Georgia?*

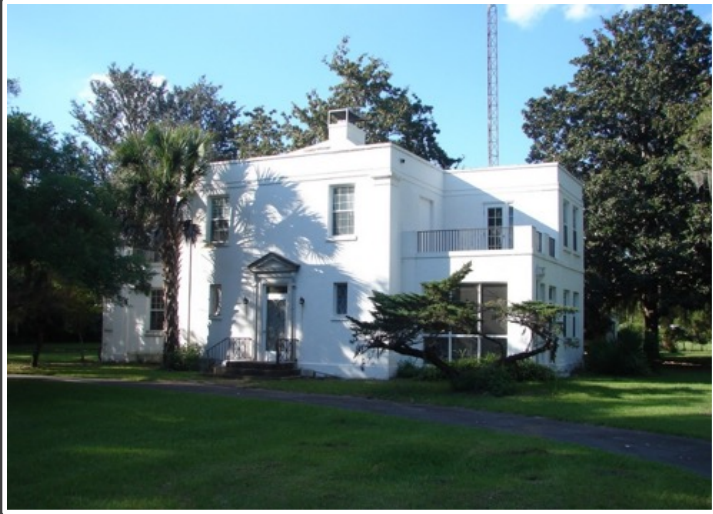
*Figure 517. Azalea Cottage, 2015*

**Azalea Cottage – UGA 6085 (1934, Category 2)** Azalea Cottage was built circa 1936 by R. J. Reynolds as a small private residence. It is located at a remote location north of the Reynolds Mansion. Reynolds later used the cottage as a retirement home and had an oxygen system installed in the house to help him deal with his emphysema. The cottage also served as the Marine Institute Director's house. The cottage is currently unoccupied but is sometimes used to house guests.

Azalea Cottage is a compact two-story painted stucco building with living spaces on the first floor and bedrooms on the second floor. Pilasters frame the primary façade at the building's corners and a parapet masks the sloping roof behind. The first floor is organized around a central living room that opens to the rear of the building. The second floor includes a large master bedroom with adjacent spaces and two smaller bedrooms.

The 2002 reservation plan notes that the cottage had been recently painted with elastomeric paint, membrane roofing had been installed, and the building's casement windows had been replaced with new vinyl windows. Existing windows are double-hung. Significant architectural detailing has been retained, including built-in shelving and ceramic tile. The 2002 plan also noted moisture infiltration problems. Despite the window changes, the cottage retains high integrity and is assessed as Category 2.

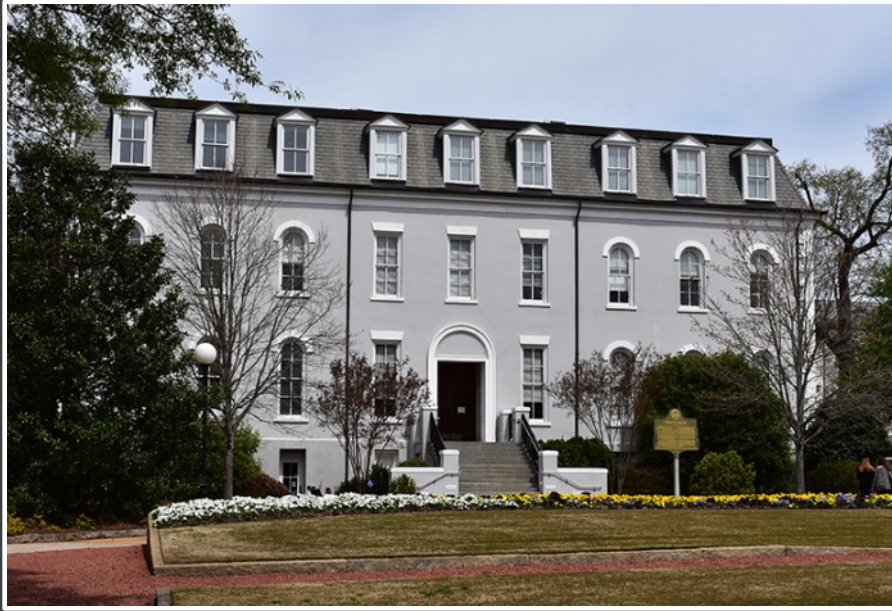
# Case Study: Window Replacement at Moore College

**Recommended Significance:** Yes

**Building Use:** Educational: Administration

**Foundation Materials:** Brick

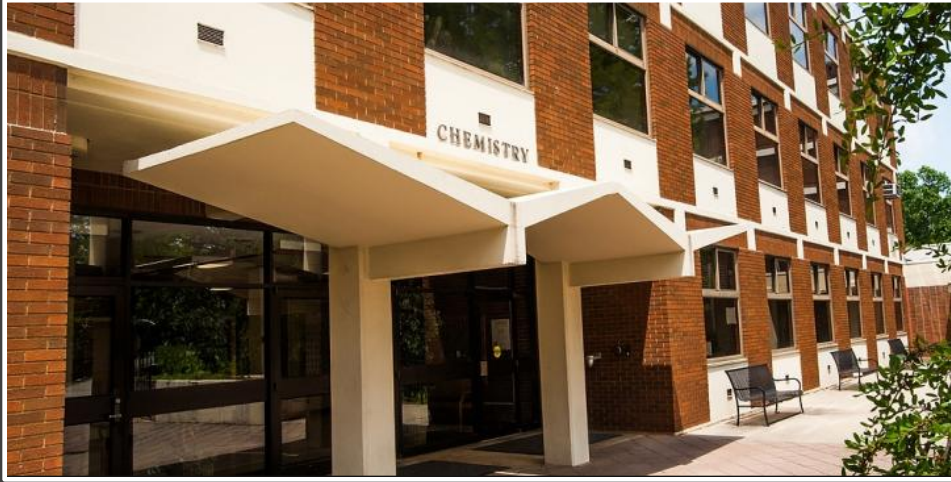
# Case Study: Consider Demolition of Chemistry Addition

**Recommended Significance:** Yes

**Building Use:** Educational: Research Facility

**Foundation Materials:** Concrete Block

**Notes:** Complex plan with a series of attached asymmetrical wings. Largely brick veneer with concrete detail used to visually organize windows and stories. Wings distinct in design, all use same organizational pattern. Abstract voussoirs drop down from belt courses to distinguish bays (without forming complete vertical line). Entry block is 12 bays wide, indicated by each column of windows, three stories high. Thin concrete voussoirs placed vertically, unites horizontal bands running between windows. Brick is horizontal at window sides; rectangular concrete panel below windows; fixed rectangular window above panel and horizontal sash window at top.
